**Building Preservation Guidelines
Historic Preservation Commission
City of New Richmond**

**Volume II
Buildings 15-31**

New Richmond
Wisconsin
54017

July 2000

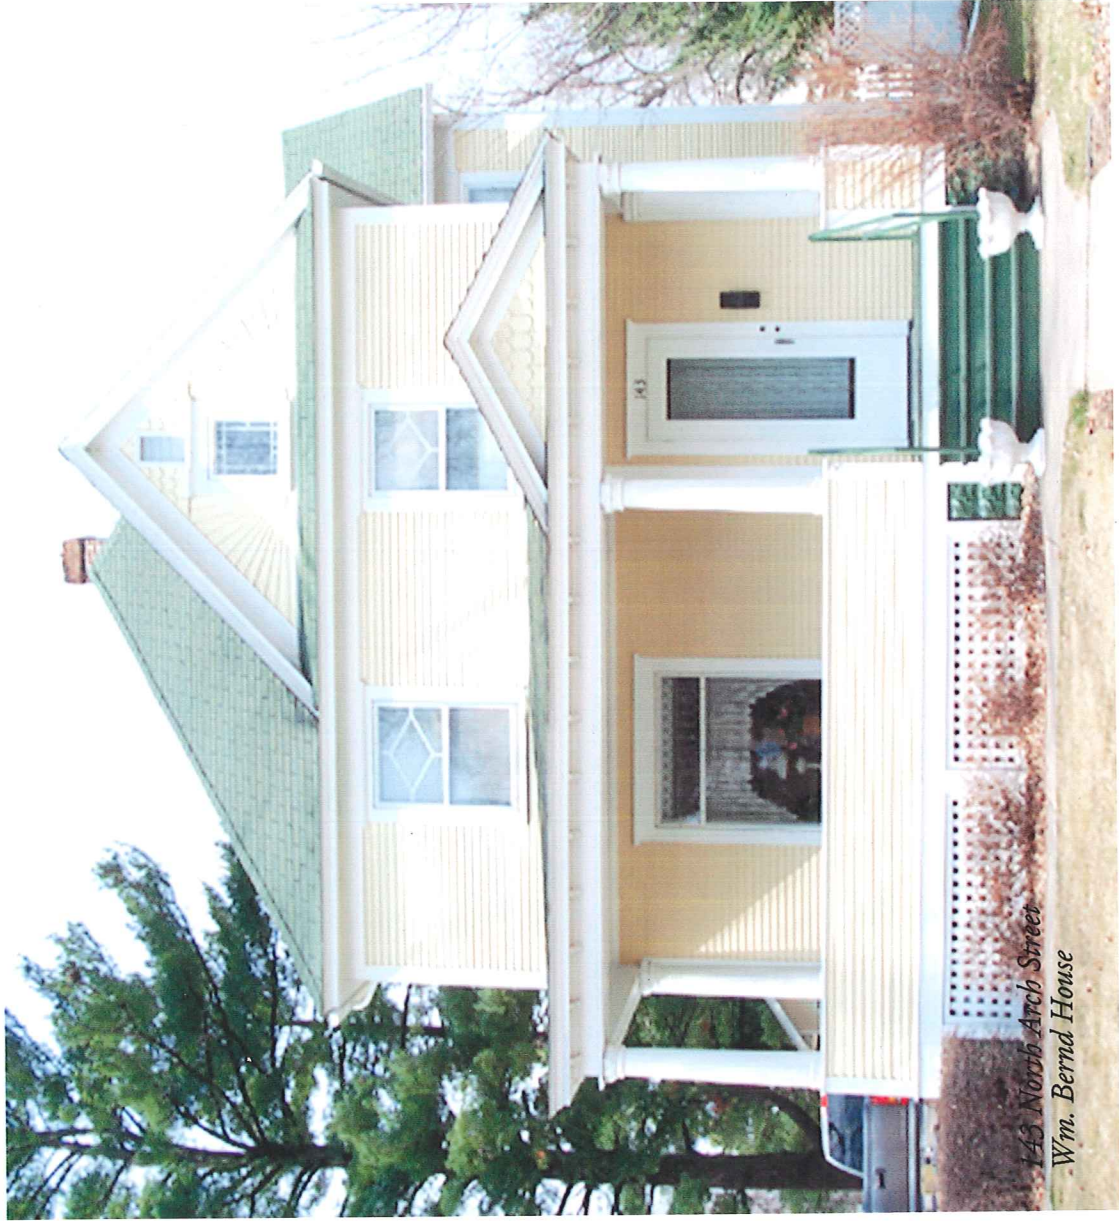
143 North Arch Street
Wm. Bernd House

- A. The original storms have been replaced with aluminum storms. When these are replaced the replacement should be vinyl or wood edged units of a cross section matching the original.

- A. The foundation should be painted a masonry color.

- A. Fed into the building on a primary elevation, it should be painted to match house and foundation. Landscaping should be employed to screen it from street view.

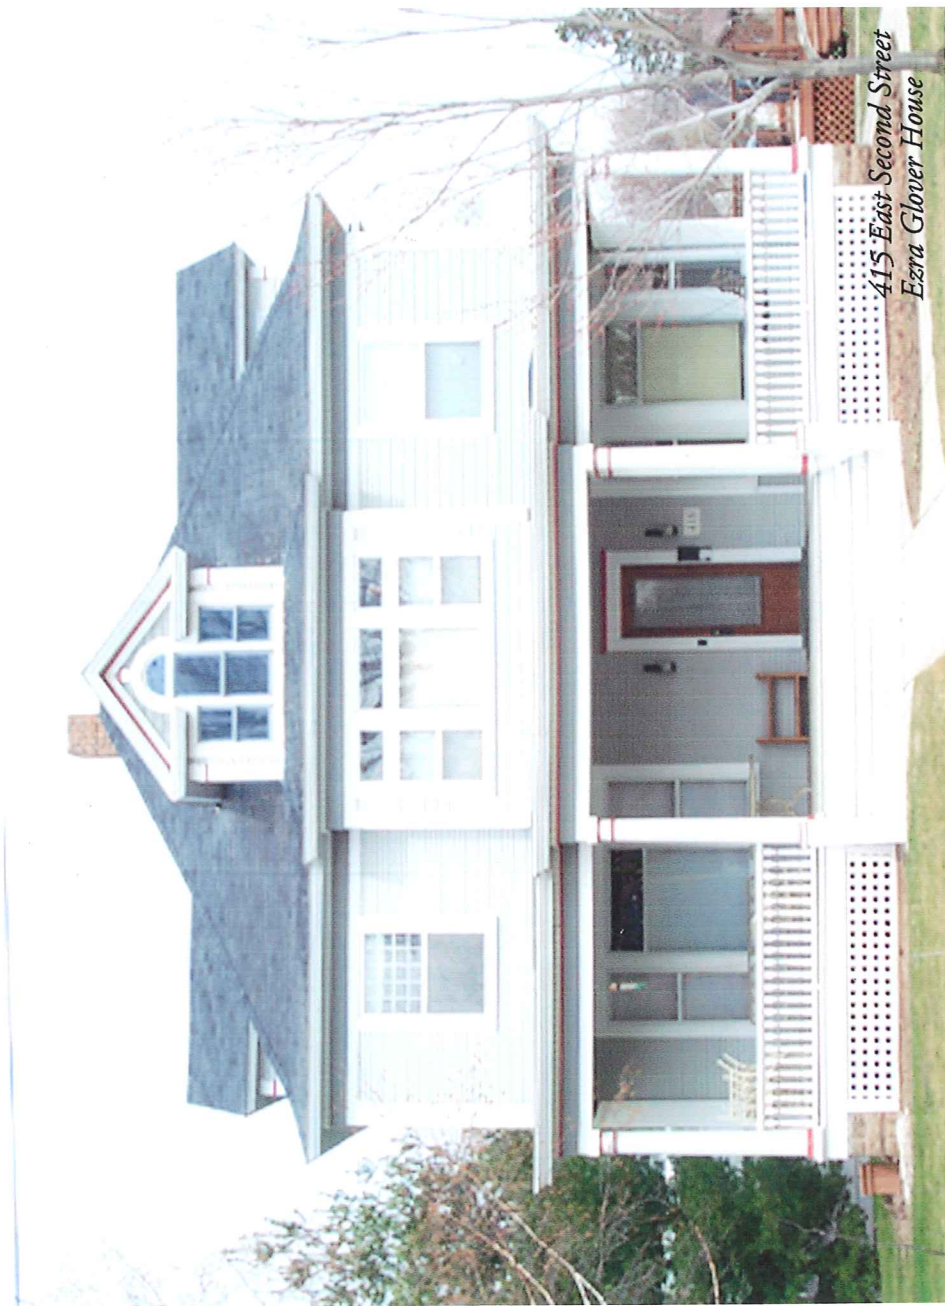
415 East Second Street
Ezra Glover House

A. Considerable work has been done to the soffits and eaves of this house. It is unclear just what the original design was. The corner pilasters terminate under the eave suggesting a missing detail. Old photographs or existing paint lines may reveal the original detail.

- A. The front of the house would appear more connected to terra firma if there were foundation plantings in front of the porch.
